**Brazos River Bridge  
Erosion Project**

- ▶ **City Council approved a professional Service contract with Huitt-Zollars on November 2017 to perform the Brazos River Erosion Study along the 9 miles of River within City limits**
  - **Dr. Briaud, PhD – Texas A&M University Geotech Professor**
- ▶ **Engineering Department issued NTP on November 17, 2017**
- ▶ **Huitt-Zollars initiated the Study in December 2017**

- ▶ **Analysis of the Brazos River erosion and geomorphology (with Texas A&M University)**
- ▶ **Hydraulic and hydrologic model analyses**
- ▶ **Prediction of projected bank erosion based on historical data**
- ▶ **Survey of critical erosion areas within the City**
  - **Aerial survey and Geotechnical investigation**
- ▶ **Develop a Risk and Consequences Methodology Analysis**
- ▶ **Communications with stakeholders**
- ▶ **Presentation of results to CoSL and Stakeholders**

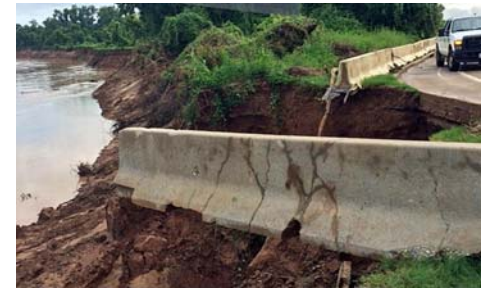
TXDOT US 59 Turn Around

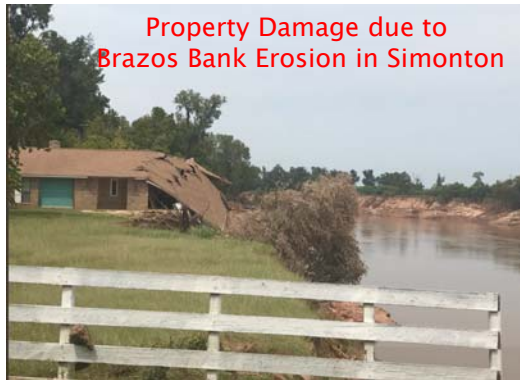
Property Damage due to  
Brazos Bank Erosion in Simonton

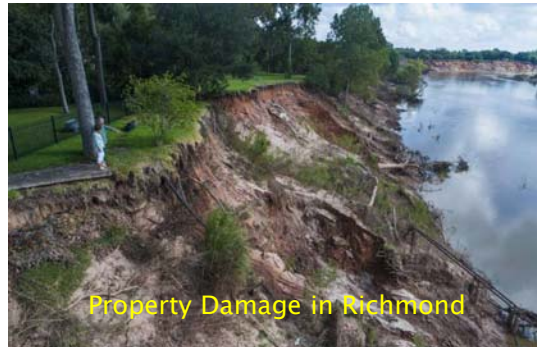
Property Damage in Richmond

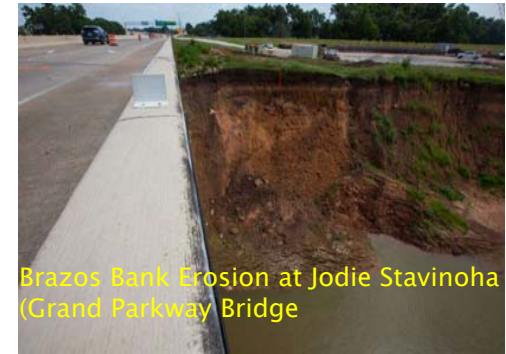
Brazos Bank Erosion at Jodie Stavinoha  
(Grand Parkway Bridge)

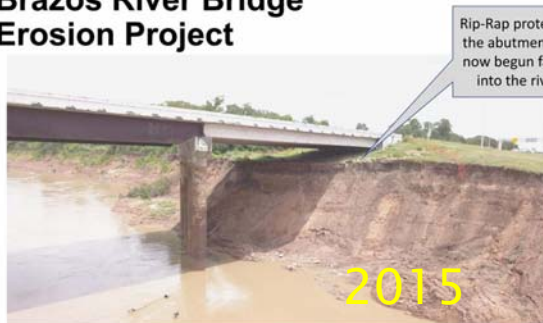
Rip-Rap protecting  
the abutment has  
now begun falling  
into the river.
